Pentium[®] II Processor Specification Update

Release Date: June 1997

Order Number: 243337-002

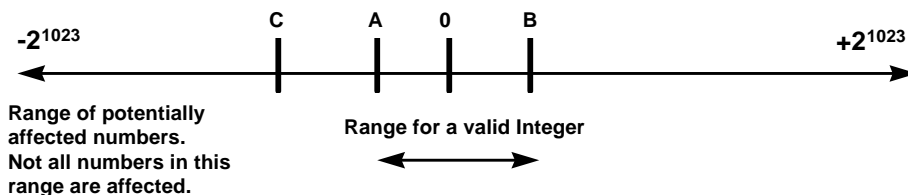
IMPLICATION: Erroneous operation results when the operand is so large that it will not fit into the target data size. The operands affected by this erratum are significantly outside (by a factor of 3X) the range that can be, correctly, converted to an integer value. The figure below and corresponding table identifies the normal range of integer numbers (between A and B) and the starting point of the operands affected by this erratum. Discrete failing operands will be present in the range between point C and the maximum negative number that can be represented by the processor (-2^{1023} in double precision format). Note 2 below gives a qualitative description of the nature of the discrete failing values. Software that does not rely on the Invalid Operation exception flag being set and signaled by either an exception OR by software polling is not impacted by this erratum.

16-bit Operation	A	B	C
	-32,768.0	+32,767.0	< -98304.0
32-bit Operation	A	B	C
	-2,147,483,648.0	+2,147,483,647.0	< -6,442,450,944.0

WORKAROUND: Any of two software workarounds will avoid occurrence of this erratum:

1. Range checking performed prior to execution of the FIST[P] instruction will prevent the overflow condition from occurring, and may already be implemented as a standard coding style.
2. Software can use the presence of MAXNEG in the result integer to indicate that an out of range conversion may have occurred.
